The Uniform Building Inspection Report™

Single Family Residence:

20411 E. Point Loma Drive, Scottsdale, AZ 85259

071815A

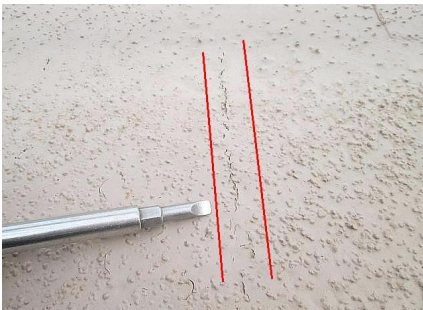
Photo: 1000 (1)

[R] 1000: Deck material at balcony has 2 or 3 small cracks developing in material. Some chipping noted at this deck with this epoxy deck apparently painted with house paint (not typical) Advise review and repair of this deck.

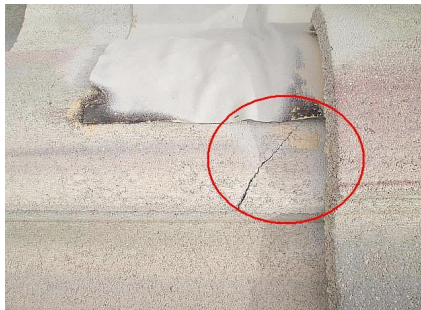
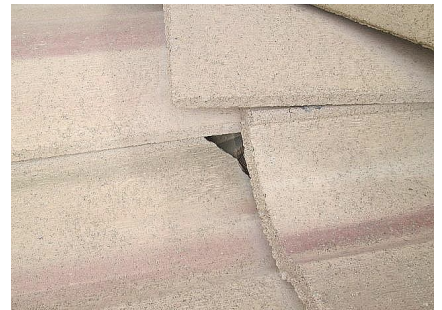
[R] 1080.01: Tile damaged at roof.
See Photo(s) 1080.01.

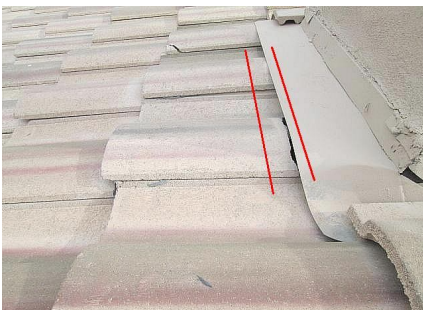
Photo: 1080.10 (1)

See Photo(s) 1080.10.

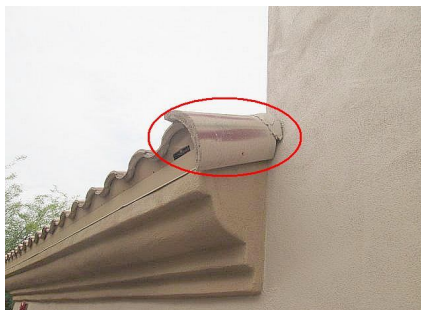
Photo: 1080.11 (1)

[R] 1080.11: Tile appears to be loose at rear East corner of garage roof.
See Photo(s) 1080.11.

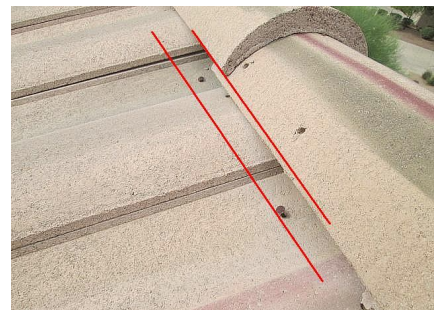
Photo: 1080.12 (1)

[R] [B] 1080.12: Roof tiles out of position or 'stretched'. Noted at upper roof hips.
See Photo(s) 1080.12.

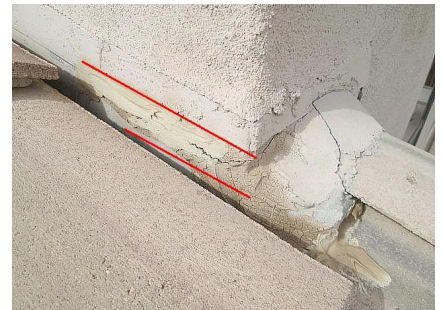
Photo: 1230.11 (1)

[R] 1230.11: Crack noted at past caulking repair at roof flashing at East side of rear balcony deck.
See Photo(s) 1230.11.

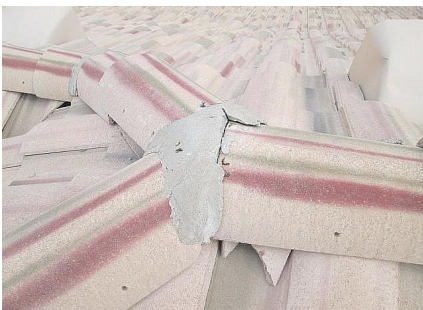
Photo: 1240 (1)

[R] [P] 1240: Mortar cap flashings cracked/separated at some areas at upper roof.

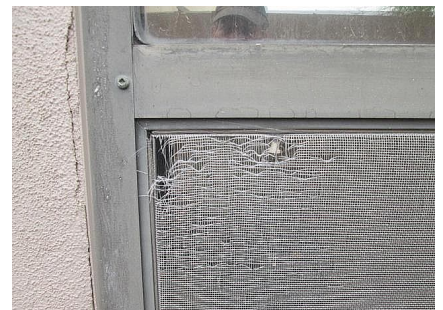
Photo: 1550 (1)

[P] 1550: Window screen has some damage at lower West side. Various screens not installed at front, rear and East sides. Several stored screens noted inside garage.
See Photo(s) 1550.

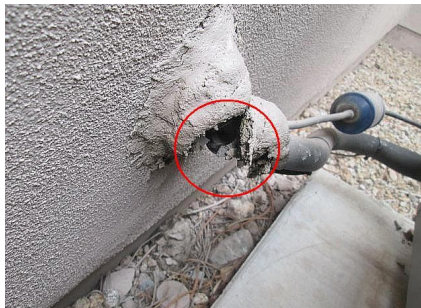
Photo: 1911 (1)

[P] 1911: Advise caulking gaps at a/c refrigerant lines at lower West exterior wall.

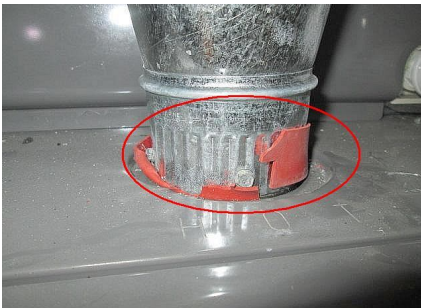
Photo: 2150.01 (1)

[P] [B] 2150.01: Apparent rubber material noted at base of furnace vent at lower hall closet - not typical material. Small hole noted at seam also at this vent. Advise proper tape material at lower vent and at small hole.

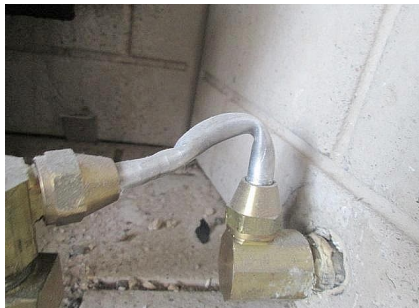
Photo: 2530.13 (1)

[B] 2530.13: Fireplace gas lines are crimped (but likely operating burners OK) at master bedroom and living room. Gas verified at fire places but log sets not ignited.
See Photo(s) 2530.13.

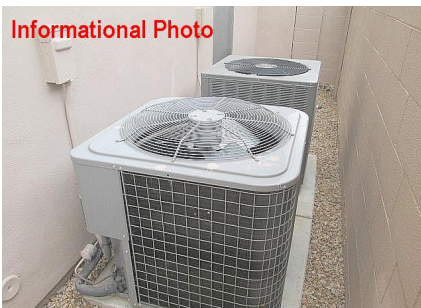
Photo: 2850 (1)

[Note] 2850: 7 year old 4-ton Carrier and 1 year old 5-ton Rheem a/c units/furnaces. Both a/c units tested acceptably in a/c mode. Not tested in heat mode due to weather conditions and occupants.
See Photo(s) 2850.

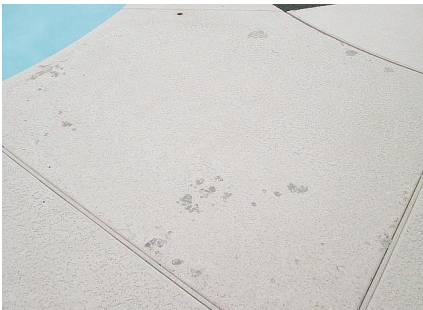
Photo: 3110.01 (1)

[P] [A] 3110.01: Minor pool deck chips noted. See Photo(s) 3110.01.

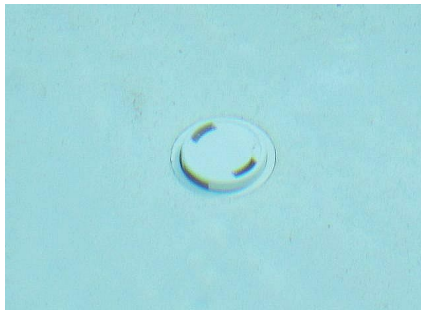
Photo: 3750.21 (1)

[R] 3750.21: Pool bottom jet cleaning system heads not all properly advancing. Advise further review.

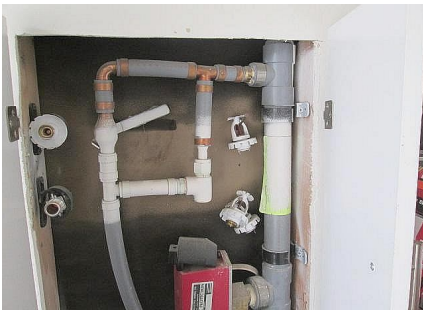
Photo: 4381.03 (1)

sprinklers with no concern noted for this piping for this application.

[B] 4381.03: Water pipe clamps are damaged with piping somewhat loose in West garage wall for fire sprinkler riser. Polybutylene piping is used for fire

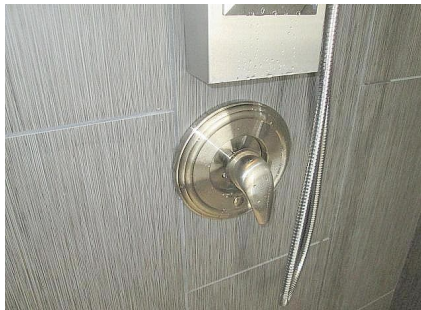
Photo: 4550.10 (1)

[R] 4550.10: Water valve handle won't stay in just hot or cold position at master shower. Advise review and repair.

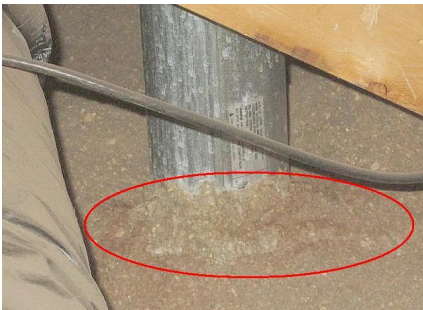
Photo: 9650 (1)

[R] 9650: Roof leak evidence noted with stains on insulation noted on vent at left side of furnace at attic. Advise review of this roof flashings if not already addressed.
See Photo(s) 9650.
