PROPERTY INSPECTION REPORT

FRAMING INSPECTION REPORT

Date of Inspection: 9/7/2021

Addr: 3455 N. Newhouse Street

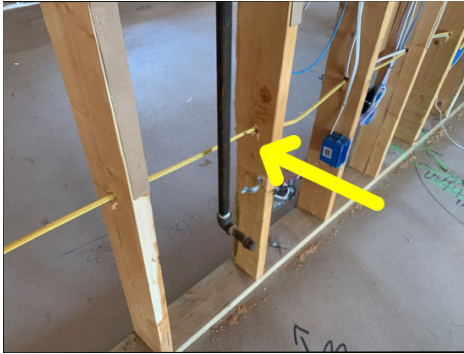
Gas line Loose at: kitchen cooktop,

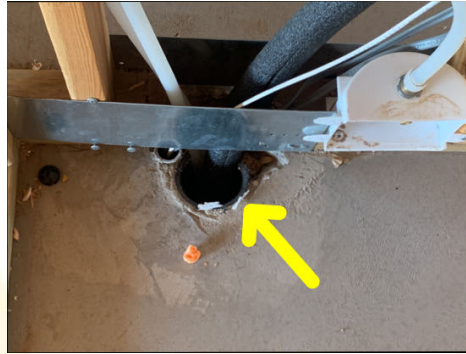
Floor sleeve not properly aligned at kitchen fridge area

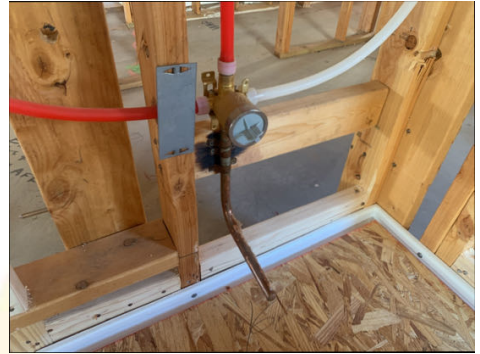
Valve and tub spout very loose at Bath number three

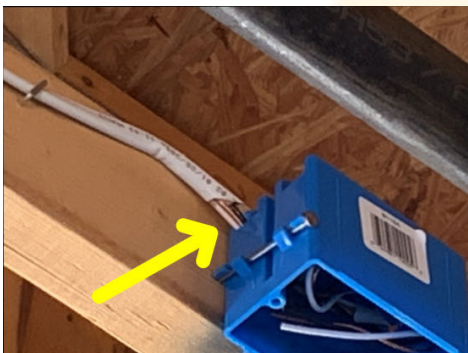
Wiring sheathing cut too short at center garage ceiling outlet box.

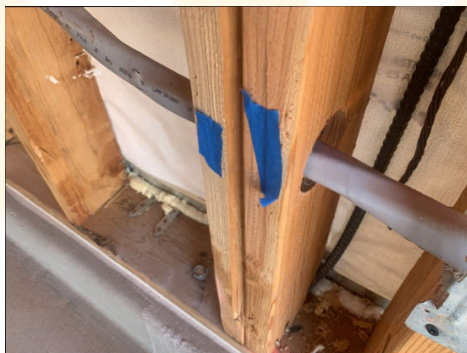
A nail plate is needed to protect the wiring that is closer than 1 1/4" from the face of the stud. Noted at: West garage wall below electrical panel at several areas,

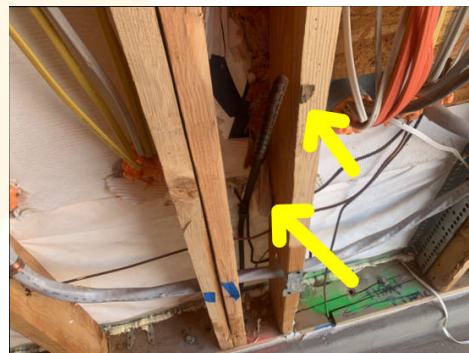
Rebar protrudes wall and trim ring missing at acorn nut for UFER splice below main panel at West garage.

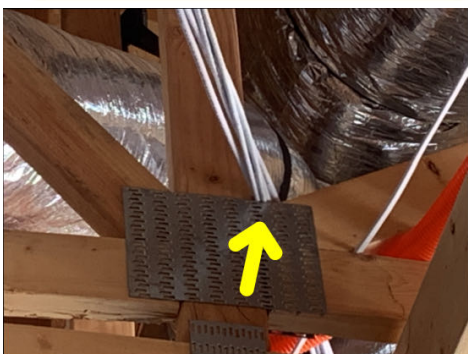
Wiring contacts sharp truss plate edge at center kitchen ceiling. As marked on the floor.

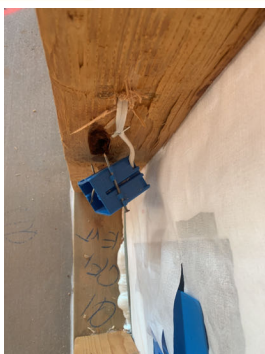
Outlet box not attached, inside east den wall

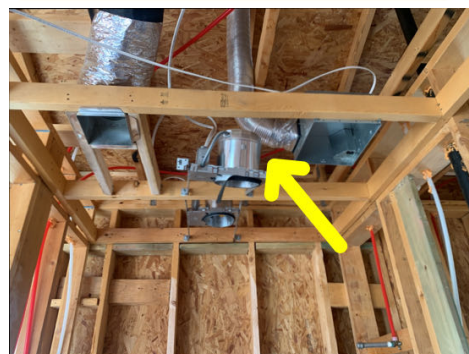
Light fixture not secured at north east bath

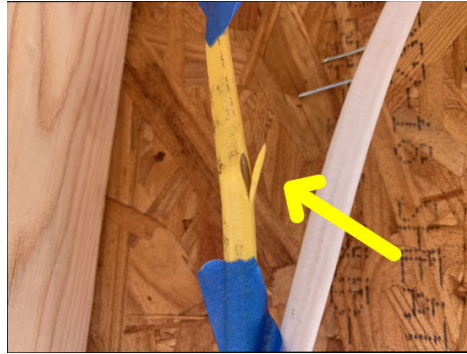
Wiring has area of damage and not secured at South East bath

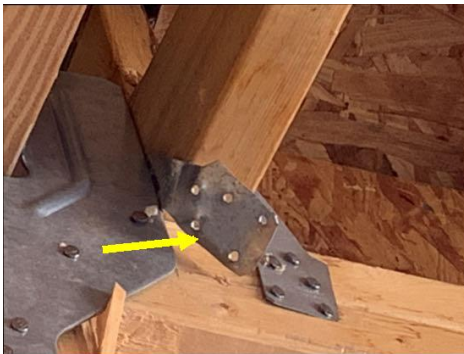
Metal bracket protrudes upper wall above side garage pedestrian door.

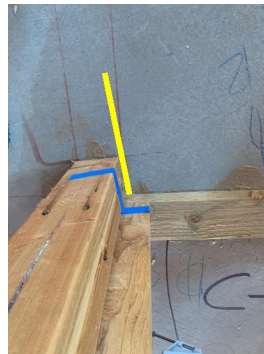
Walls are not square at . Walls should be perpendicular within 1/4" in 10'. Noted at: master water closet entry, Entry to bedroom number three,

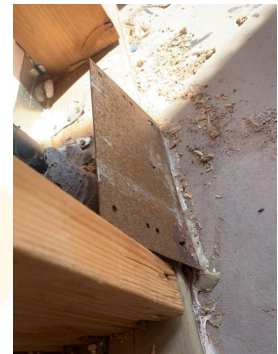
Nail plate out of position at the bottom plate below sink at South East bath

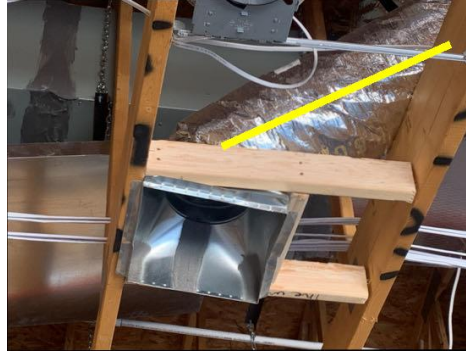
Ducting takes sharp angle, improper radius, at kitchen ceiling above the island

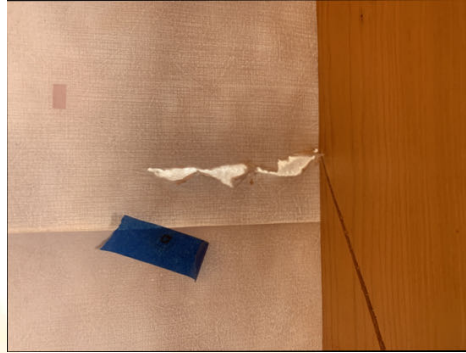
Stucco paper damaged at: West garage wall
